## Hydrologic Monitoring Network Handbook

Christopher Shuler  
Aly I. El-Kadi

WRRC Special Report SR-2018-02

Prepared in cooperation with the  
American Samoa Environmental Protection Agency  
through the US EPA Region IX Making a Visible Difference Project:  
"Tutuila Hydrogeologic Exploration"  
Project No. C00543, Project Period: 7 May 2016 – 31 December 2017  
Principal Investigator: Aly I. El-Kadi

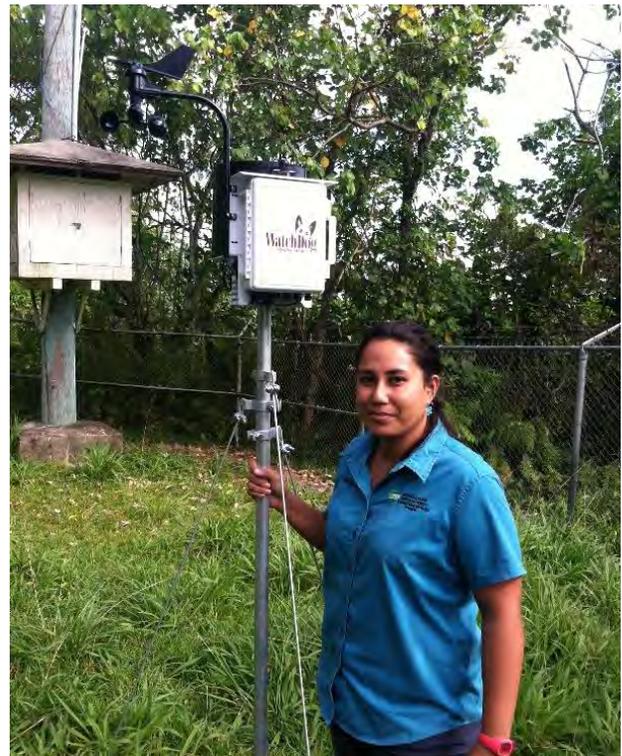
The Poloa station was installed in late 2015 and instrumented with a Spectrum Instruments WatchDog 2900ET station. The station is located in a fairly open area with a generally westerly aspect, and sits at 141 m elevation. Some nearby trees may cause interference with rainfall, and especially wind measurements. The station is mounted roughly 2 m above the ground surface on a free standing pole within the grassy area enclosed by the Poloa water tank fencing. This site is located at the top of a steep road behind a local family’s house. In the past, the family has requested that visitors stop at the house and check in with the family prior to heading up the hill to the water tank. This weather station has had issues with the rain bucket getting clogged, probably due to the nearby trees, and has also had issues with ants making nests inside the housing. It is highly recommended that tanglefoot be regularly applied to the upper section of the support pole to mitigate this problem.

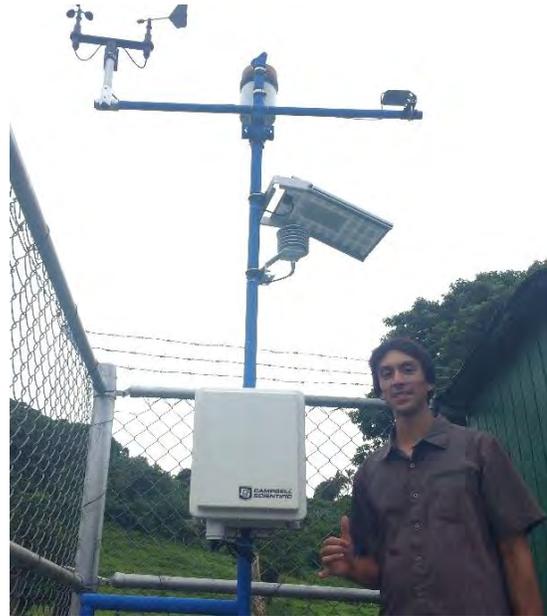
### 3.1.2. Aasu Weather Station (Latitude: -14.3098, Longitude: -170.7715, Elevation: 358 m asl)

The Aasu weather station was originally installed as a Spectrum WatchDog 2900ET station in late 2015, and replaced with a Campbell Scientific weather station in early 2017. The station is located at 355 m elevation within the fenced enclosure of well 128, on top of Aloaou Mountain. This is one of the more ideal weather station sites as it is located in the middle of a relatively flat and open cow pasture. There are a limited number of small trees throughout the pasture, but they probably do not interfere with wind or rainfall measurements. The original Aasu watchdog station was mounted on a single pole at a height of 3 m to elevate it above the chain link fence surrounding the well, and the new Campbell

station is now mounted at the same location on a three legged free standing support tower that is bolted to the concrete slab below. The SR meter, anemometer, and rain gauge are located at a height of 3 m above ground surface and temperature and RH sensors are mounted at 2 m above the ground. Access to well 128 is off of a paved concrete road accessed via a right turn within the village of Aasu while at the top of the main Aoloau Road.

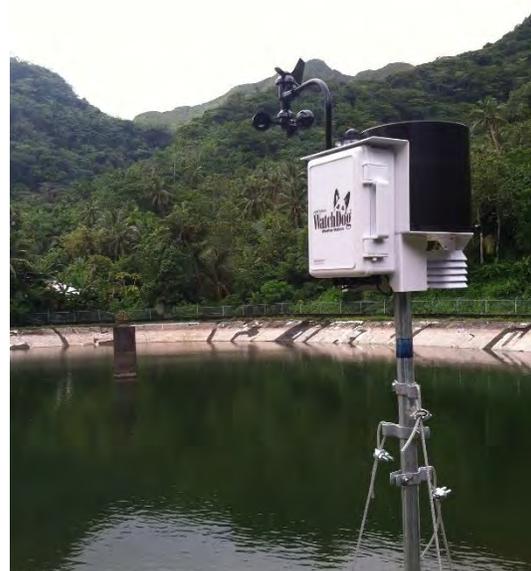
### 3.1.3. Vaipito Weather Station (Latitude: -14.2829, Longitude: -170.7105, Elevation: 92 m asl)

This station is a Spectrum Instruments WatchDog 2900ET station and was installed in late 2015. It is located in an open valley with an easterly aspect and sits at 90 m elevation. The station is in a very open area and is mounted on a free standing pole at the edge of the Vaipito Reservoir within a fenced enclosure. The instrument sits at 2 m above ground surface. Access to the Vaipito reservoir is via concrete road—right turn going up the Fagasa Pass Road.

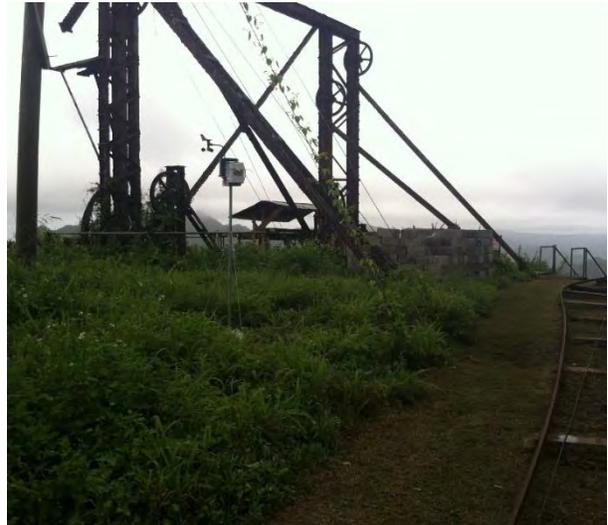
### **3.1.4. Mt. Alava Weather Station (Latitude: -14.2654, Longitude: -170.6879, Elevation: 477 m asl)**

Unfortunately, the rainfall and solar radiation readings are probably affected by the cable car structures and the wires above. This station may need to be mounted on a taller pole than the existing 2 m one, to more accurately record wind speeds. The station has been affected by ants.

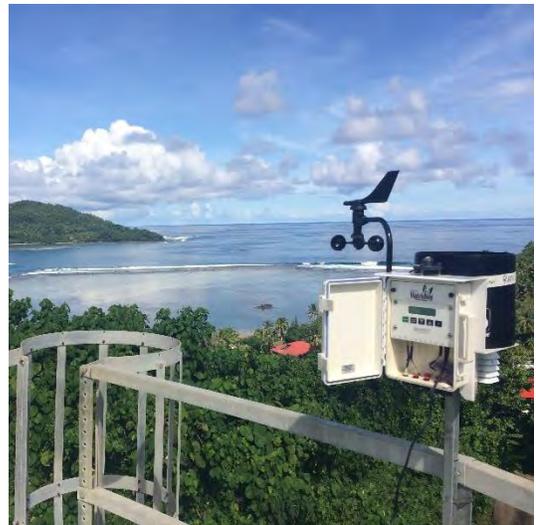
### **3.1.5. Fagaitua Weather Station (Latitude: -14.26722, Longitude: -170.6171, Elevation: 55 m asl)**

The Fagaitua site has a Spectrum WatchDog station located on top of the Fagaitua water tank. It was installed in early 2017 and is mounted on a short pole roughly 1.5 m above the roof of the tank. The tank itself is roughly 10 m above the ground and located atop a ridge, making the station significantly elevated above the ground. The ground elevation of the tank is 44 m. This is probably only a temporary station as the water tank is leaking and will need to be replaced in the near future. As of 2017, the Spectrum station computer module only records SR, wind speed and direction, temperature, and RH. A separate tipping rain bucket was installed to replace the faulty rain gauge and has a dedicated data logger made by RainWise Inc. The rain logger is downloaded with the RainWise software and records one data point per minute during active rainfall only. Therefore, a specific processing routine must be applied to this data.

The Fagaitua tank is located at the top of a steep concrete road and has no vehicle turnaround at the top. The tank has a ladder that must be ascended to access the station, and past observations suggest this ladder may be a hangout for large yellow wasps.

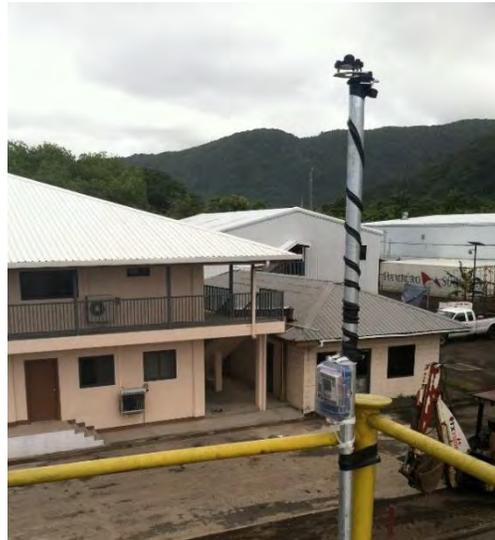
### 3.1.6. ASPA Solar Radiation Meter (Latitude: -14.3203, Longitude: -170.7417, Elevation: 30 m asl)

This station consists of a small pyronanometer and a data logger only. The solar radiation meter is mounted on top of a 2 m pole attached to the top rail of the yellow staircase on the roughly 15 m tall southerly fuel tank at the ASPA compound, which sits at a ground elevation of 14.6 m. The station is accessed by hopping over the containment wall and walking up the yellow staircase to the top of the tank. This logger can be downloaded by the Spectrum Data Shuttle.

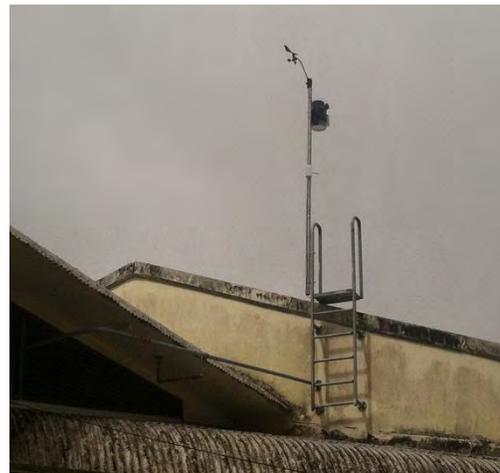
### 3.1.7. ASCC Weather Station (Latitude: -14.3203, Longitude: -170.7417, Elevation: 65 m asl)

This station is located at a ground elevation of 49 m and is mounted on top of the Land Grant building roof at a height of 16 m above the ground. This station replaces a former station that was deployed in the same location in the past. The station is maintained by Land Grant staff. Data is available by download from

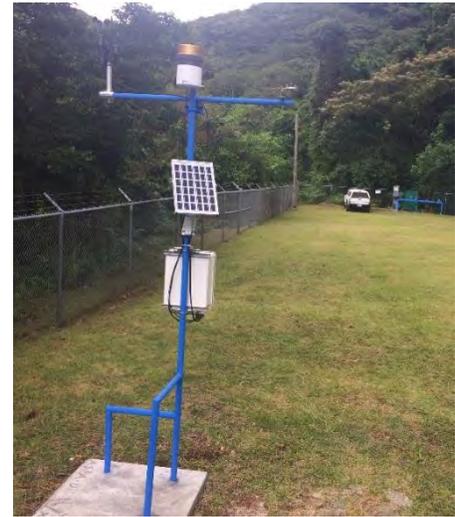
### **3.1.8. Afono Weather Station (Latitude: -14.26738, Longitude: -170.65058, Elevation: 84 m asl)**

The Afono weather station is a Campbell Scientific weather station and was installed on a custom built free standing tri-legged tower in early 2017. The tower is mounted in concrete foundation located in the north east corner of the Afono water tank enclosure. The SR meter, anemometer, and rain gauge are located at a height of 3 m above ground surface, and temperature and RH sensors are mounted at 2 m above the ground. The area around the weather station is generally grassy and open, but a nearby tree may provide some interference with rainfall and wind measurements. The site is located along the Afono pass road and sits at 81 m asl.

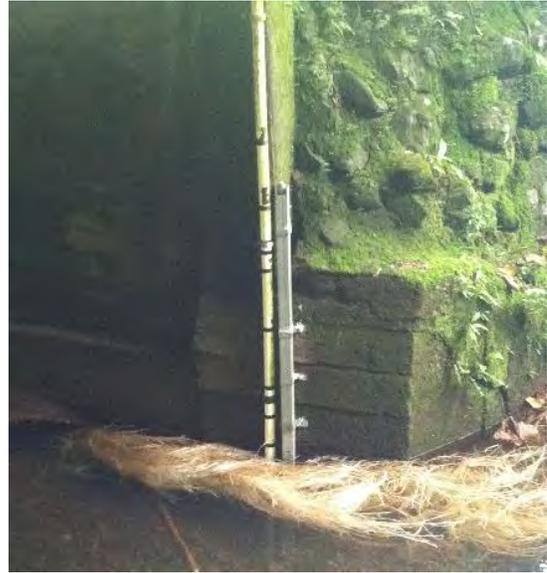
Additionally, this bridge was instrumented with a temporary stream gauge by a researcher from San Diego for a couple of years prior to this project; however, that instrument has since been removed. A staff gauge (with English graduations in 10ths of feet) is mounted to the PT housing and can be read from across the stream. At this site, the channel is controlled on both sides by the bridge abutments

and the gauging pool is fairly deep (about 40 cm at low water). The level control currently consists of a rock bar and is subject to being moved in a flood. Data consistency at this site would be improved by installation of a weir. Both high- and low-flow discharge measurements have been taken underneath or just downstream of the bridge.

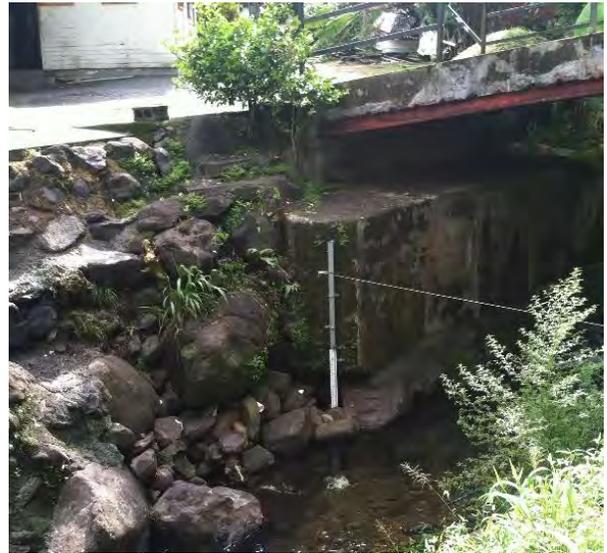
The Fagasa stream gauge is located on the river right side of a small bridge leading to a family's house. The bridge crosses the stream directly off of the right side of the main road to Fagasa Village, and is located about 100 m up from the coastline. The channel is deep and hard to get into, so the housing has been extended to the top of the bridge where the PT can be accessed without climbing down. A staff gauge (with English graduations in 10ths of feet) is mounted to the PT housing and can be read from across the stream. At this site, the channel is controlled on both sides by the bridge abutments and the gauging pool is deep. At low water the level is controlled by a boulder jam below the pool. This site has been a USGS low-flow partial record site in the past. At the time of this writing this pool is habitat for a number of large freshwater eels. The level control is vulnerable movement in a flood, so data consistency at this site would be improved by installation of a weir. Discharge measurements are difficult to take on this steep and rocky section of stream and both high and low flows have been measured about 15m downstream of the bridge in a reasonably straight section.

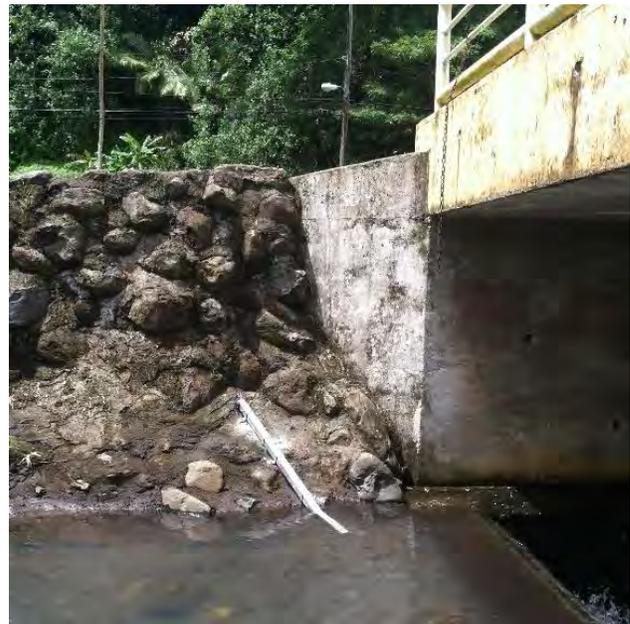
The Leone stream gauge is located on river left and is mounted to a sloping concrete wall adjacent to a large concrete bridge leading to a local family’s house. The site is accessed through another family’s front yard. The bridge is visible on the western side of the Leone Valley Road, which is accessed by turning north off the main road at the large Catholic Church in Leone Village. The road really starts up at the back of the church parking lot and is difficult to find. The stream channel is wide, and is easily accessible by scrambling down the sloping concrete banks above the bridge. A staff gauge (with English graduations in 10ths of feet) is located directly across the stream on the right side of the bridge. The level control for this site is a very stable flow over a weir type structure created by the base of the bridge support. The water flows into a compartment under the bridge, which poses a significant water safety hazard at high flows. Do not be swept into the area under the bridge, as this could have serious consequences. Though the site is fairly stable, the PT housing may be subject to sedimentation and needs to be regularly checked to ensure it is kept clear of debris. The channel directly in front of the bridge is an ideal location for gauging measurements, though it may become dangerous at high flows.

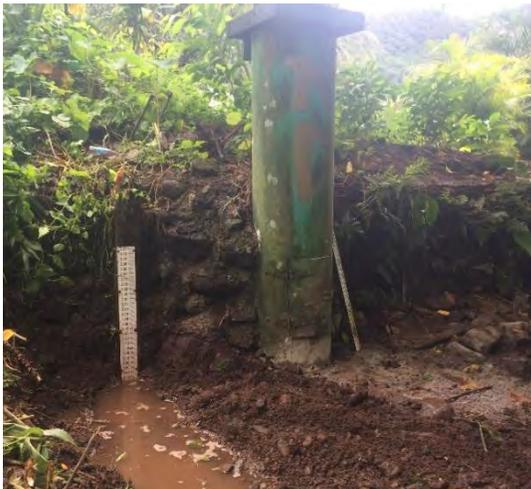
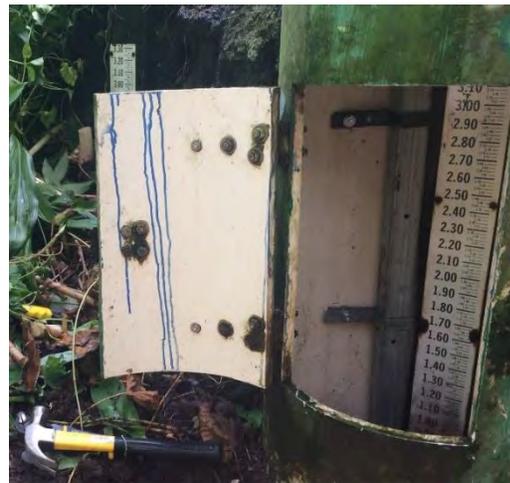
The Vaipito stream gauge is located at an out of use and fully sediment-filled village water reservoir located in a local family's backyard. This site was previously instrumented by the USGS, and still retains the old stilling well, which was cleaned out and put back into use. The site is accessed from a side road that is about 500 m up the Fagasa Pass Road. The side road crosses a bridge on the south side of the Fagasa Pass Road and is located next to a blue painted bus stop. From the side road, the backyard is accessed through a left turn into a narrow driveway between rock walls just before the road curves right. In early 2014, the site was instrumented with a short housing on the river right side of the stream that was directly mounted to the dam itself. This location was impacted by excessive sedimentation, therefore, on 26 April 2017 the old USGS stilling well was renovated and the PT was moved from the short housing to a new one inside the stilling well. Two old USGS staff gauges are intact at the site. One gauge is mounted inside of the stilling well and another is located outside of the stilling well. The level for this site is controlled by the dam, which makes a stable u-notch weir type structure. Discharge measurements can be taken at a location about 30 m upstream of the dam at a straight section of the stream, or measurements can be taken at the location of the stilling well. Due to the significant drop below the dam, caution should always be exercised when wading at this site.

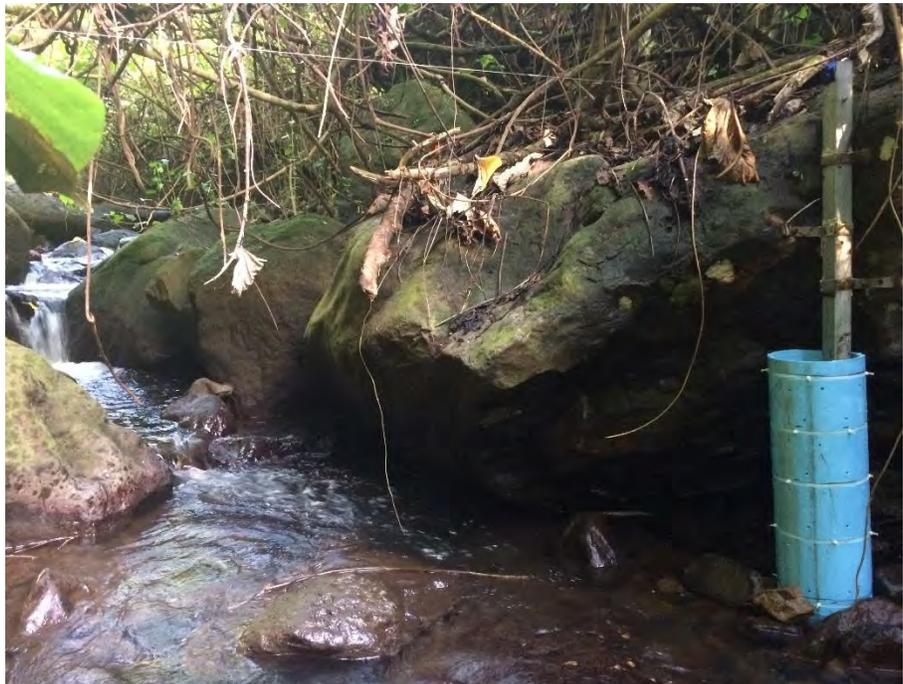
The Maloata stream gauge is located on the river right side of the stream, upstream of the main road crossing. The site is accessed by the main road to Maloata Valley, and the PT housing is visible from the road. The PT housing is mounted to a large boulder and is suspended in a slow moving pool behind the road culvert/ford. The level is controlled by the road culvert/ford. At low flow the stream stage is controlled by the rocks in front of the culverts, and at high flow the water flows over the road and the stage is controlled by a combination of water flowing through the culverts and over the sloping road surface. The channel banks are natural material consisting of large boulders that may or may not be stable. A staff gauge (with English graduations in 10ths of feet) is mounted on a river left boulder upstream from the road and downstream from the PT housing. This stream was a USGS continuous record site in the past, though the original site was located about 100 to 200 m upstream at an old, now broken, village water system dam. Quality discharge measurements are difficult to take on this steep and rocky section and both high- and low-flow measurements have been taken in the pool just above the road crossing, or upstream of the old USGS site.

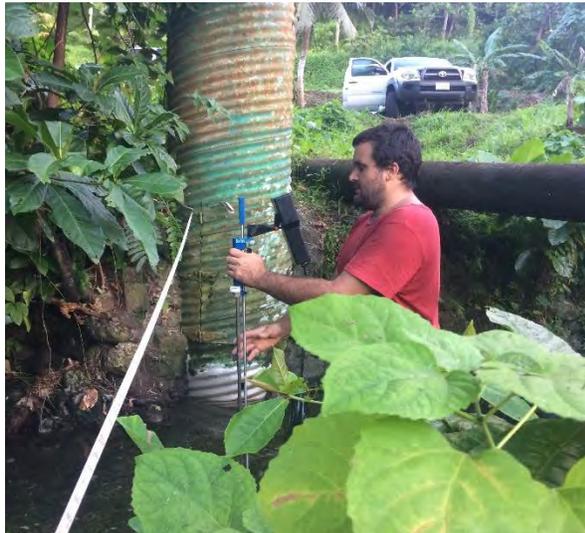
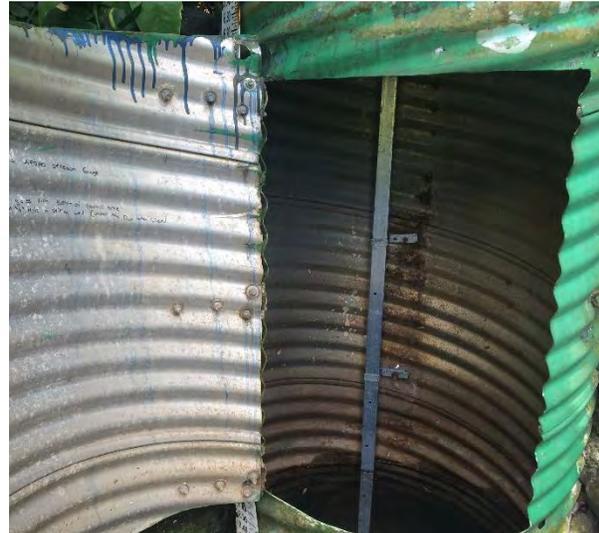
The Afono stream gauge is located at the site of an older USGS continuous record gaging station, and utilizes the old stilling well on river left that remains at the site. In addition to the old stilling well, the site has remnants of a small concrete weir that controls low flows. The gauge was installed in early 2017. The stream is channelized by gabions on the left side of the stream, however the river-right side is a natural bank of alluvium. The site is located on the side of the Afono Village access road, and a small log footbridge extends across the stream. The PT housing is constructed in the same style as the other gauges in the ASPA network, but is located inside of the old stilling well, which needs to be unlocked at the top for access to the transducer, or at the bottom for access to the bottom of the well (for cleaning and maintenance). Upon installation, the stilling well was filled with sediment (and prawns), and it is likely that sediment will need to be removed periodically in the future. A staff gauge is strapped to the outside of the stilling well for easy reading.

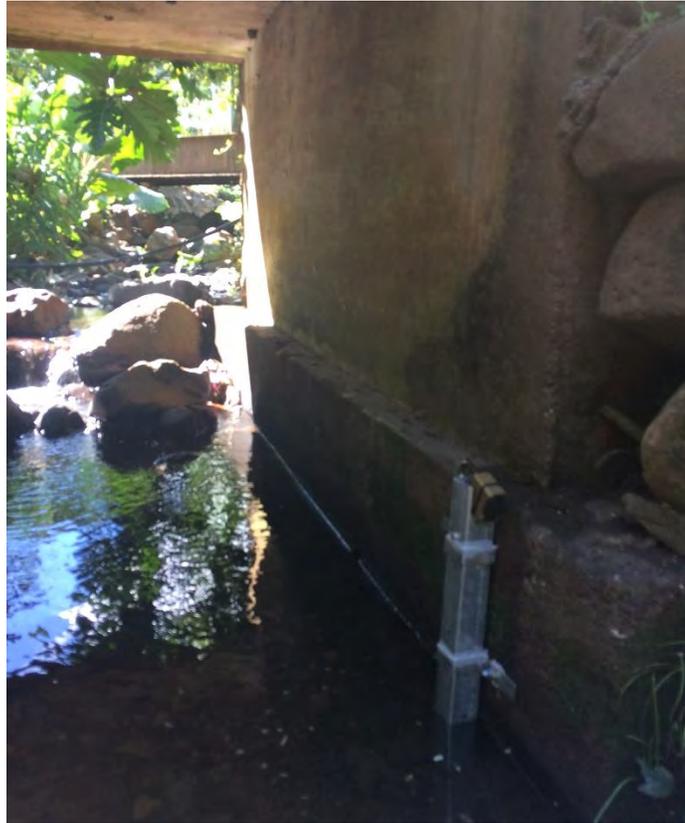
The Fagaitua stream gauge is located on a small residential bridge. The bridge serves a single family’s home, and is located just below the confluence that brings together the two main branches of Fagaitua Stream. The PT was installed in early 2017, in a short housing strapped to the river-left side of the bridge abutment. A temporary staff gauge consisting of a construction ruler was installed, but a more durable gauge is needed as a replacement. Upon installation, the area under the bridge was cleared of large rocks, a task which may need to be repeated periodically after large floods. Discharge measurements have primarily been taken just downstream of the bridge. The site is accessed by turning north off of the main road and heading up a small concrete road that passes the Fagaitua water tank. The bridge is just past the water tank, north-west of a dirt turnaround, at the local senator’s house.

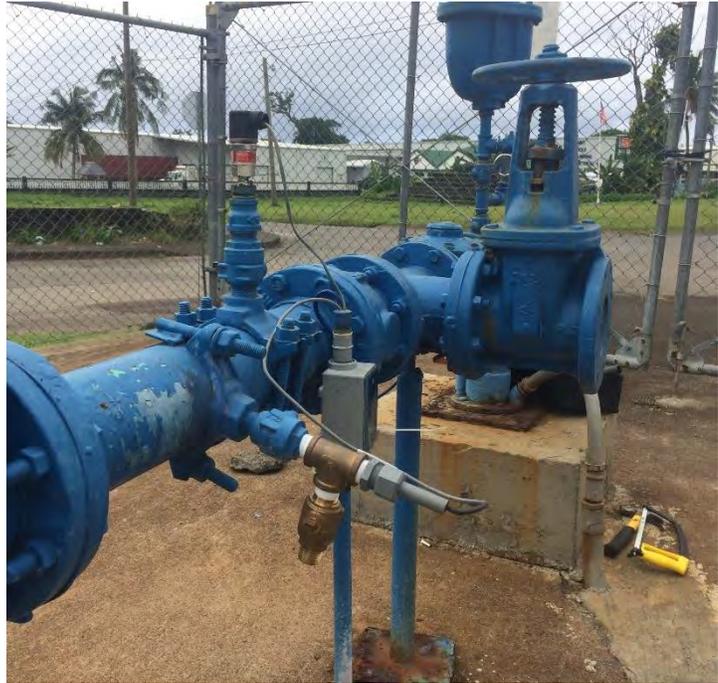
Well 33 was selected because it is central to a high-production well-field region, is designated as a groundwater under the direct influence of surface water (GUDI) well, and because it has an ASPA telemetry (SCADA) system already installed. The aquifer monitoring instruments deployed at this well transmit analog signals through the SCADA network so data can be interpreted, logged, and read out at ASPA headquarters via the ClearSCADA human machine interface (HMI, fancy word for software). Water levels are read by a Geokon (4500c) small diameter vibrating-wire piezometer that is

installed below the water table through the well's sounding tube. This instrument is directly wired to a Geokon (8020-59) frequency to an analog converter that outputs a 4-20 mA signal to the SCADA system. Electrical conductivity is monitored in the production stream with an Aquamatrix (AS-M-1-P-1) contacting conductivity sensor with stainless steel electrodes connected to an Aquamatrix (AM-2250TX) Transmitter that converts the conductivity sensor output to a 4-20 mA signal. The sensor is mounted in a brass housing that is hot-tapped to the main production line, before in-line chlorination. The sensor housing has a ball valve on the bottom that allows a small drip of water to escape so that a minimal flow past the sensor is maintained. (Note: we still need to measure the height of the measuring point above the concrete slab).

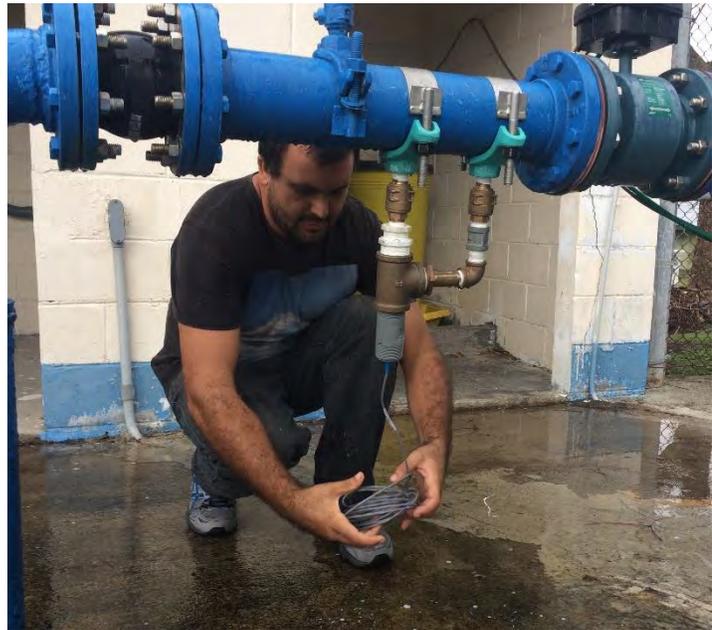
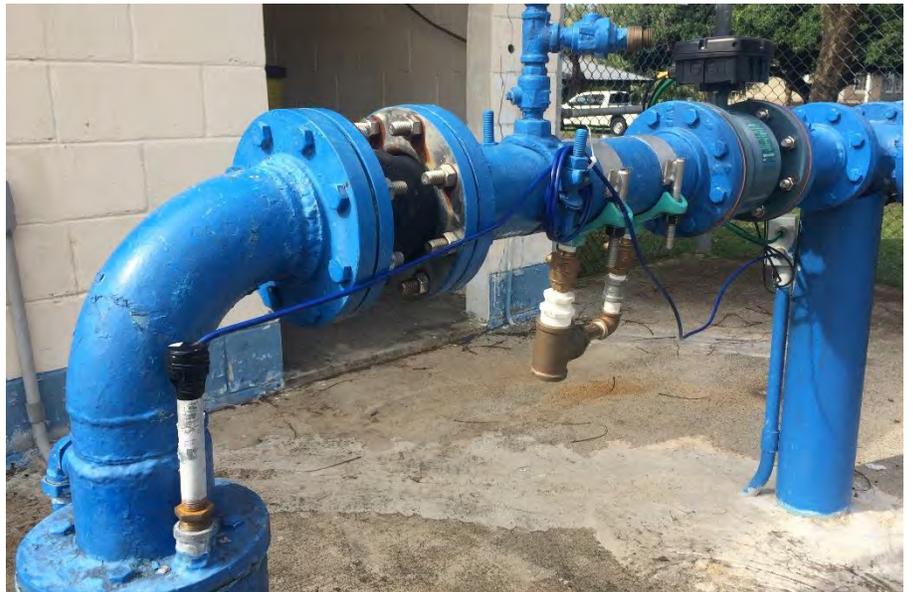
reduction and modulation of flow through the sensor. Well 62 has no well-pad riser, but the casing itself extends 62 cm off of the concrete well slab, and the top of the sounding tube stands about 20 cm above the casing top.

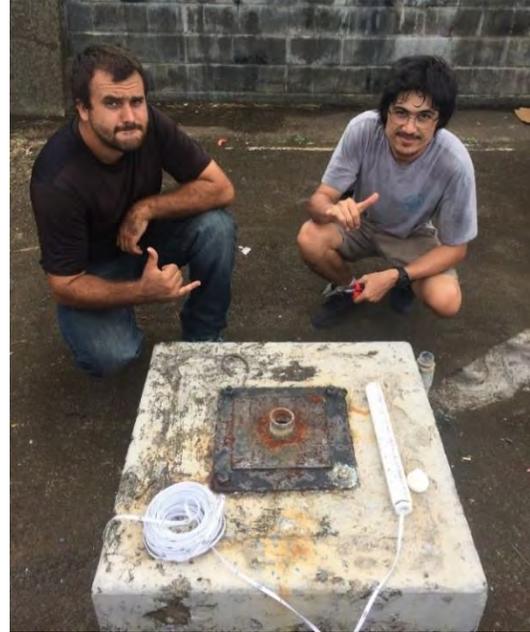
### 5.1.3. Monitoring Well 46 (Latitude: -14.324392, Longitude: -170.732229, Elevation: 23.5 m asl)

Well 46 was shut down in 2016, since it is designated as a GUDI well and is located less than 10 m to the west of Well 33. Therefore, pumping effects from Well 33, pumping at an average of 200 GPM, will most certainly be reflected in the water levels at Well 46. The well pump was pulled out in 2016 and a steel plate with a 1.5 inch threaded port was welded on to the top of the casing in early 2017. The instrument package deployed in August 2017 consists of a HOBO water level logger (U20-001-01) and a HOBO conductivity logger (U24-002-C) inside of a PVC casing that was deployed at 25 m below the casing lip. At the time of deployment, the water level was 23.4 m below land surface and weather conditions had been dry for a number of days. The fiberglass tape suspending the instruments is tied to the PVC cap at the top of the well to maintain a consistent depth below the casing. Excess tape was stored discretely inside of an old pipe running from the well port to the side of the wellhead slab. Water level measurements were taken from the top of the threaded port.

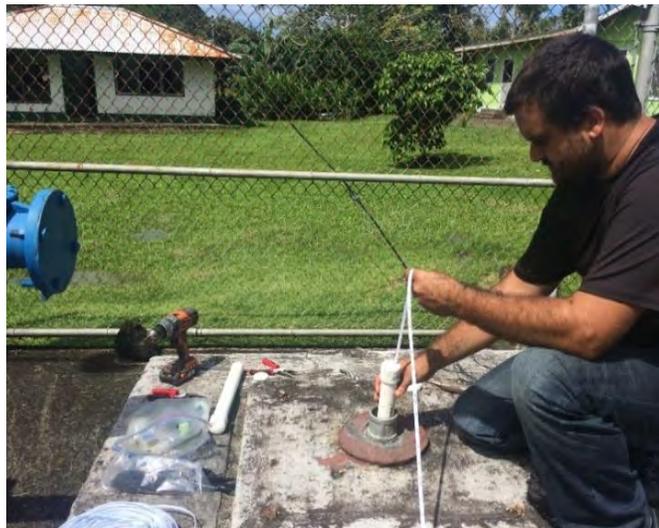
### 5.1.4. Monitoring Well 92 (Latitude: -14.342872, Longitude: -170.767561, Elevation: 49.0 m asl)

Well 92 was put out of production prior to 2013. It is located between two other active pumping wells—Well 91 located about 230 m to the south and Well 93 located about 140 m to the north. Therefore its water level is likely affected somewhat by the pumping drawdown in these wells, which both pump at an average rate around 200 to 300 GPM. A steel plate with a 2 inch threaded port was welded on to the top of the casing in late 2017. The instrument package deployed in August 2017 consists of a HOBO water

level logger (U20-001-01) and a HOBO conductivity logger (U24-002-C) inside of a PVC casing deployed at 51.5 m below the top of the casing. At the time of deployment, the water level was 49.2 m below land surface and weather conditions had been dry for a number of days. Well 92 has two well-pad risers that together stand 53 cm above the concrete well slab, and the top of the 2 inch diameter monitoring well port stands 8 cm above the concrete well slab. The measuring point where water level measurements were taken is the lip of the threaded port. The fiberglass tape suspending the instruments is tied to the PVC cap to maintain a consistent depth below the casing and excess tape was stored discretely inside of an old pipe running from the well port to the side of the wellhead slab.

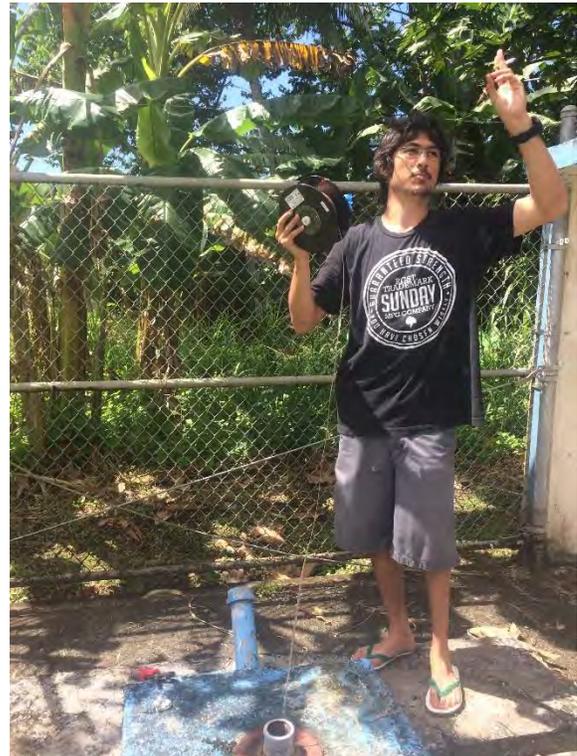
Well 80 was designated as a contaminated well and was abandoned in 2014. Well 80 is located about 180 m to the northeast of Well 70, which typically pumps at about 350 to 400 GPM. Well 80's water level may be somewhat affected by pumping drawdown at Well 70. Typical static water levels at Well 80 are around 40 to 42 m below land surface. A steel plate with a 2 inch threaded port was welded on to the top of the casing in late 2017. The well-pad riser stands 21 cm off of the concrete well slab, and the top of the 2 inch diameter monitoring well port stands 8 cm above the concrete well slab. As of this writing, the sensor package has not been deployed due to complications with potentially hazardous items located at the bottom of the well. Once the well is logged and cleaned out, the sensor package should be deployed about 2 m below water level.

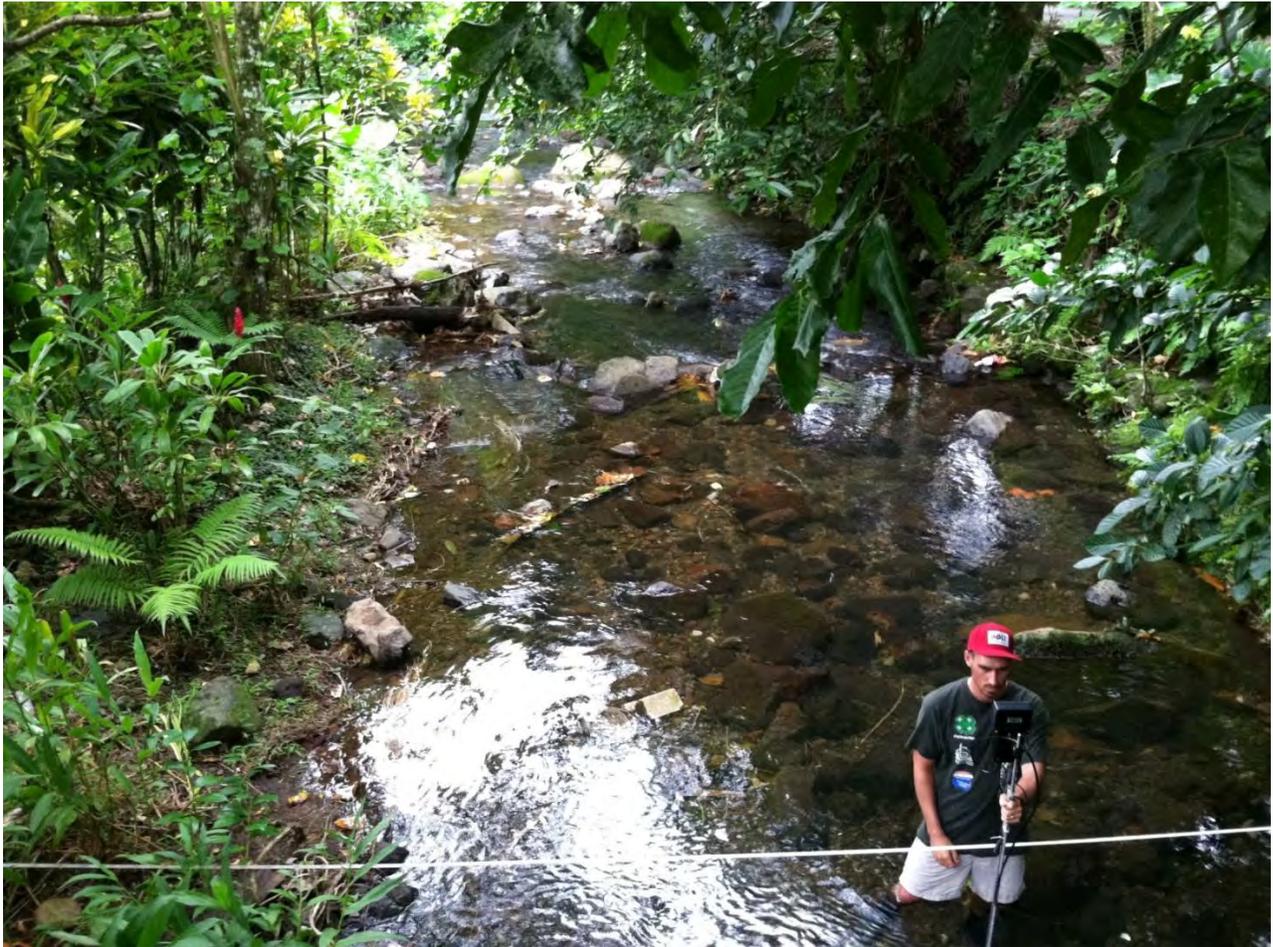
Control structure for Nuuuli gage, rock bar in background. April 2016

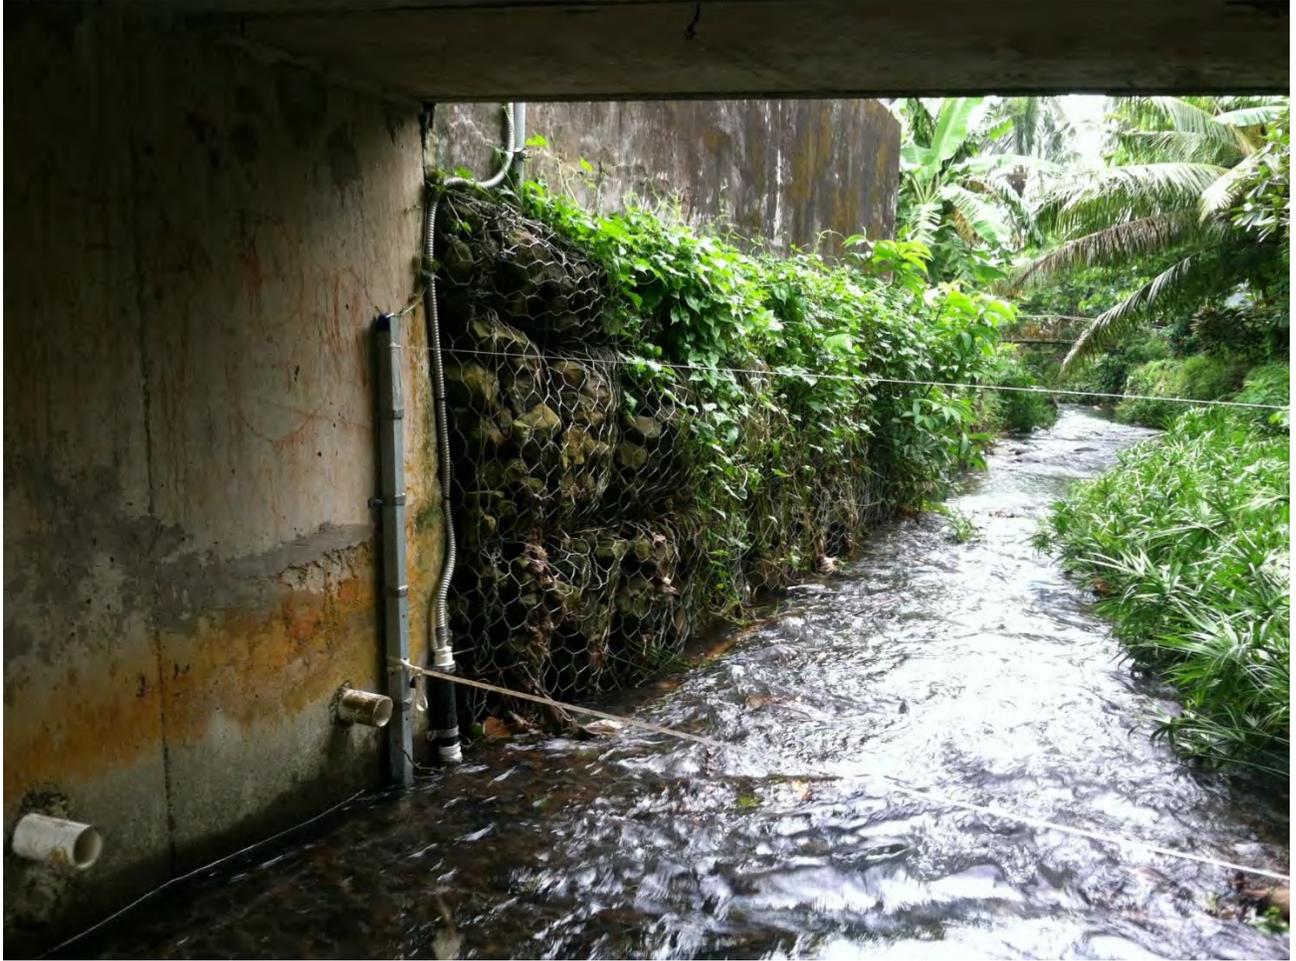
Control structure for Fagaalu gage, downstream channel control. April 2016

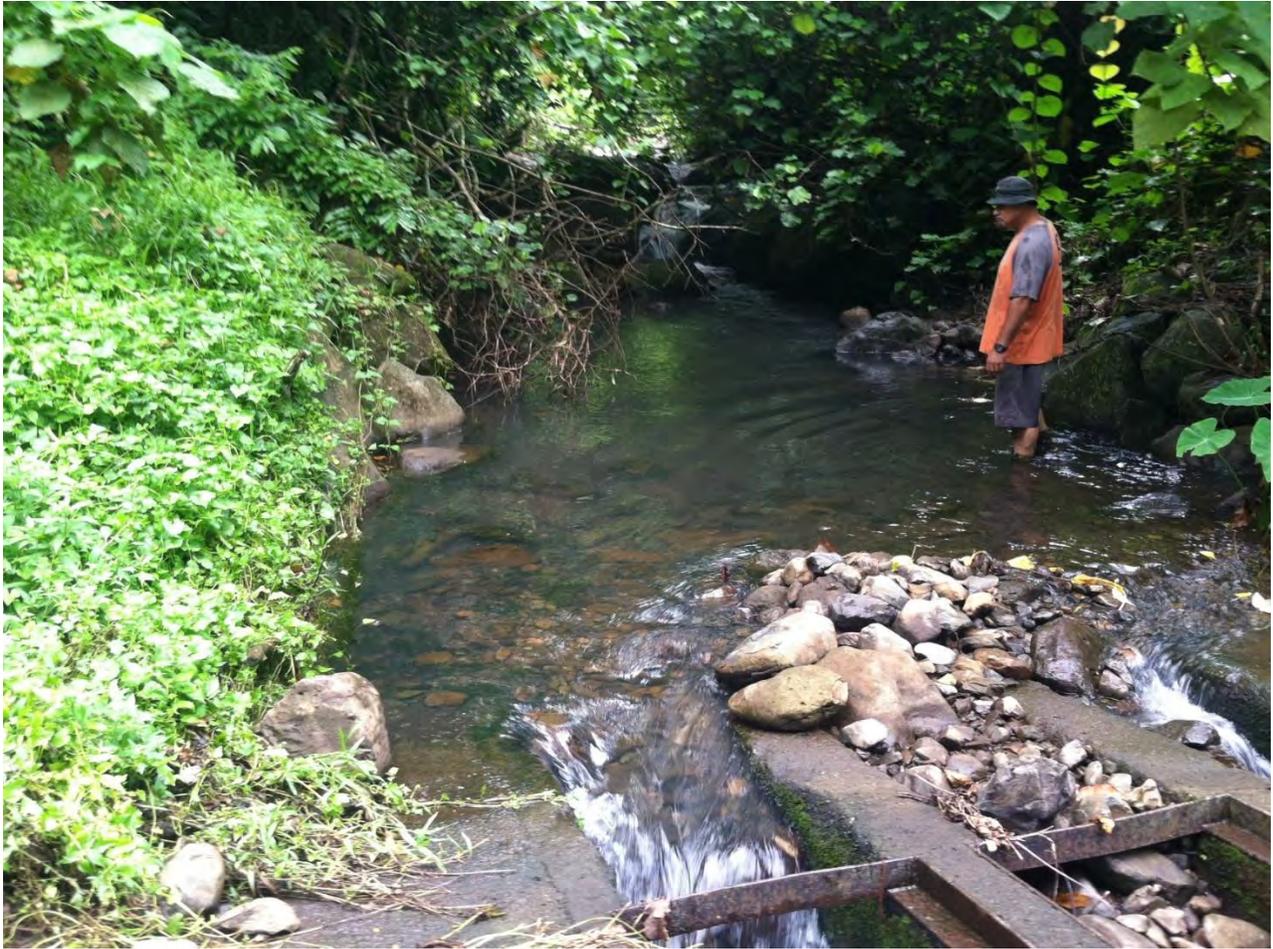
Control structure for Malota gage, rocks piled at culvert entrances. April 2016

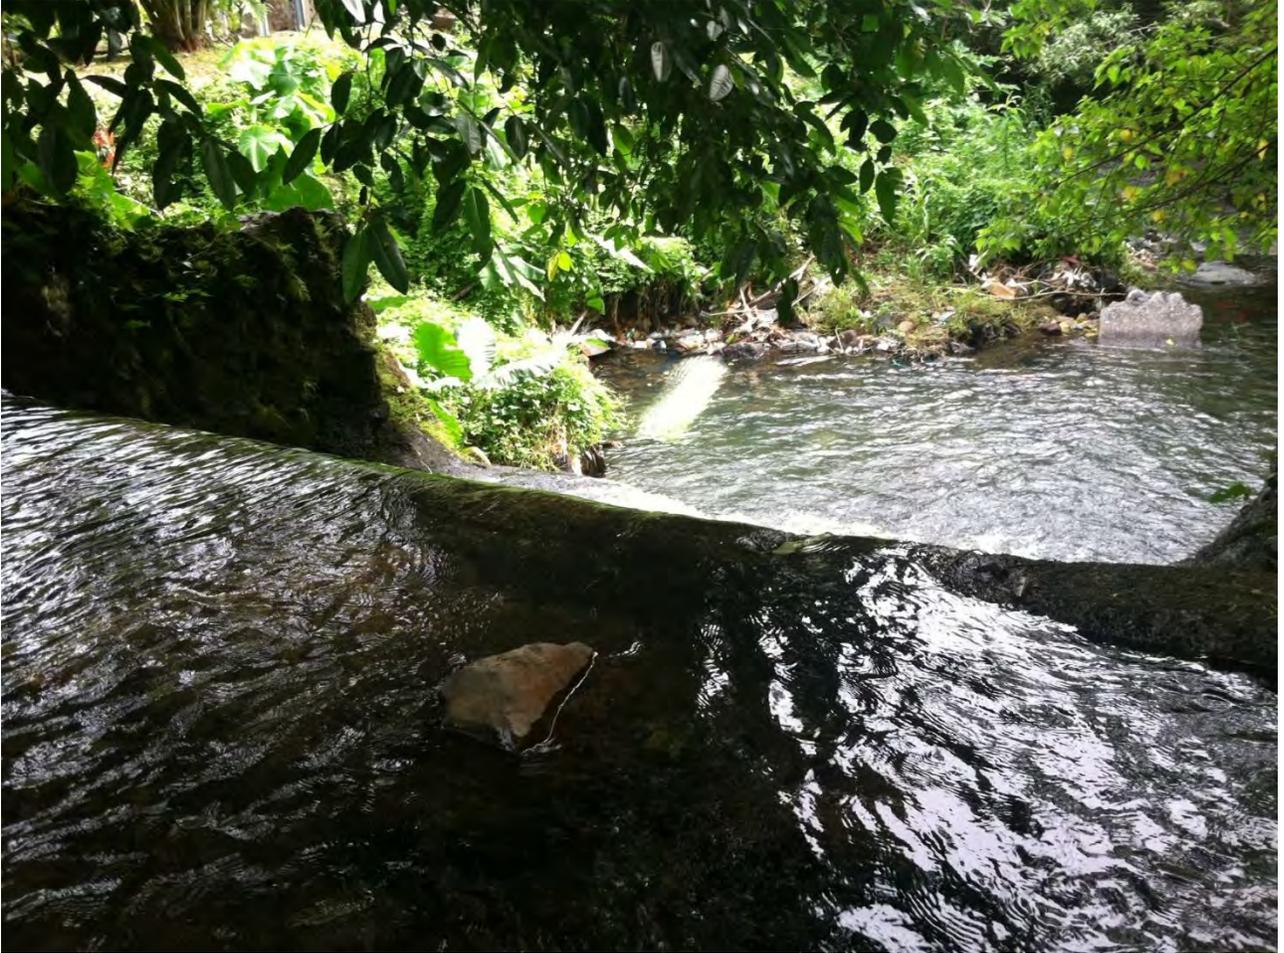
Control structure for Vaipito gage, lip of dam. April 2016

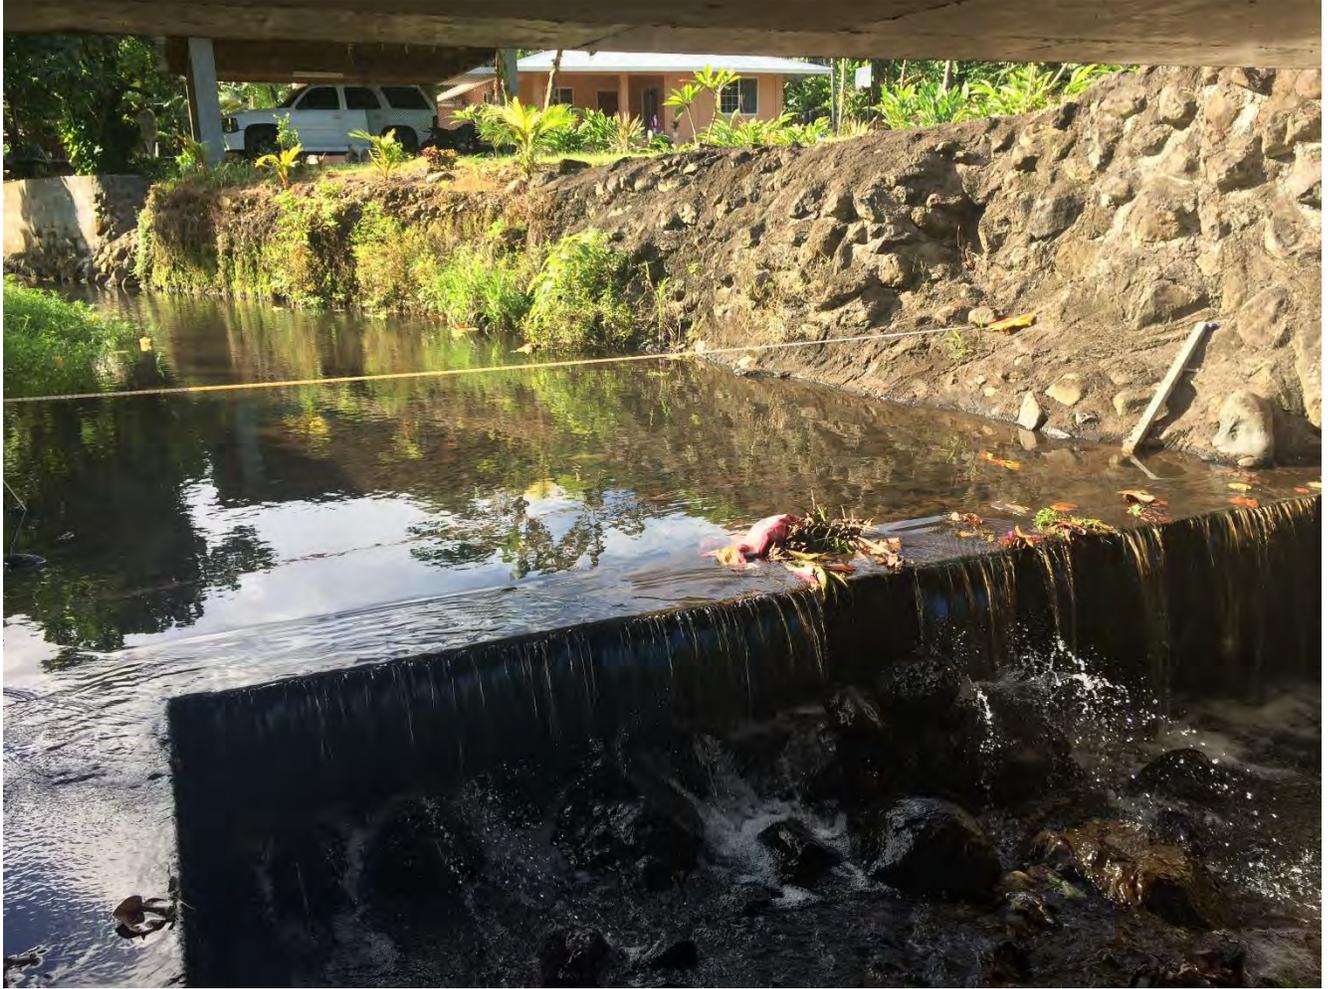
Control structure for Leone gage, lip of bridge base. April 2017

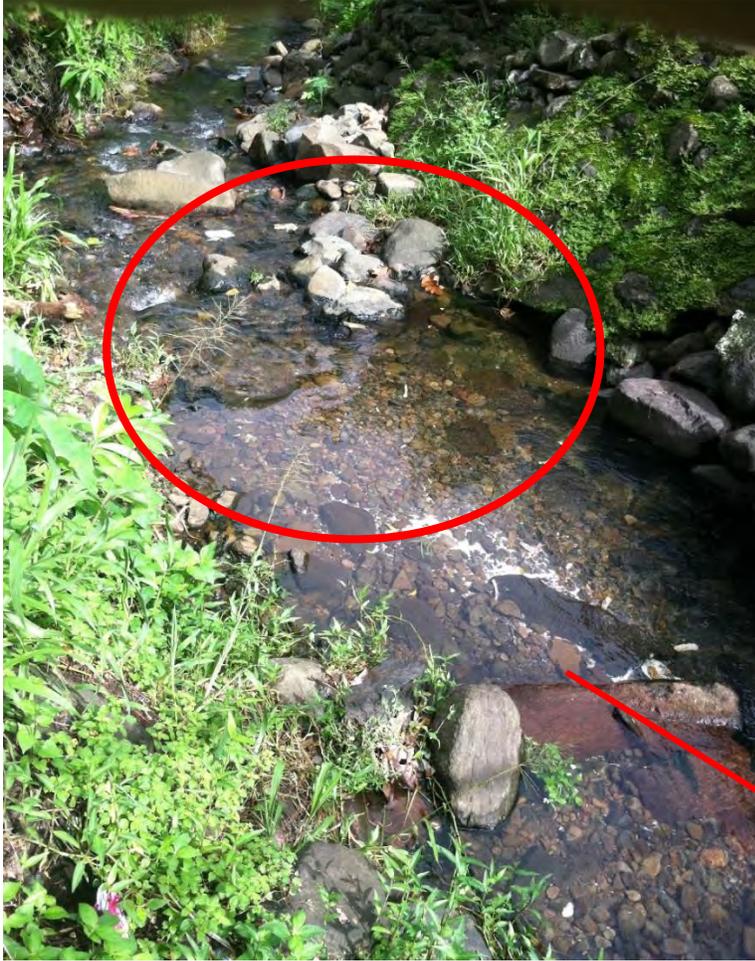
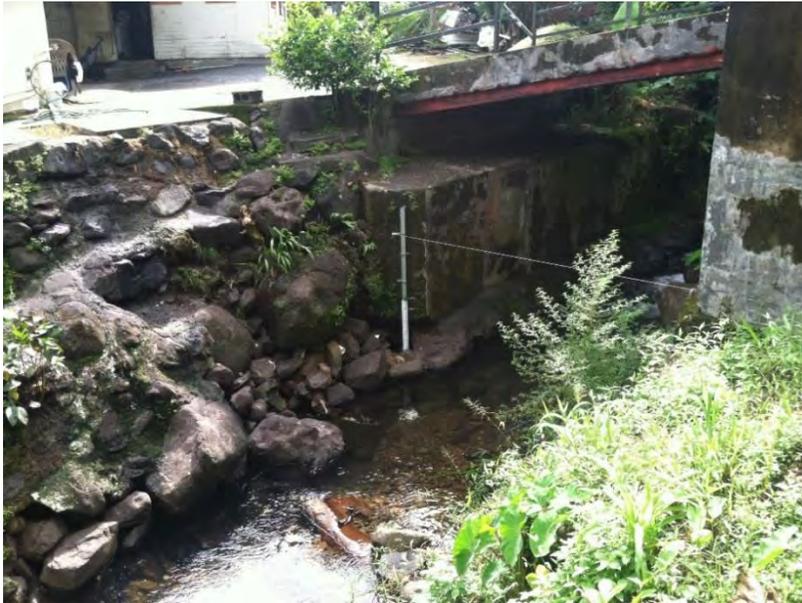
Control structure for Fagasa gage, rock bar in top center of top photo. Note position of red rock in both photos. April 2016
