## Hydrologic Monitoring Network Handbook

Christopher Shuler  
Aly I. El-Kadi

WRRC Special Report SR-2018-02

Prepared in cooperation with the  
American Samoa Environmental Protection Agency  
through the US EPA Region IX Making a Visible Difference Project:  
"Tutuila Hydrogeologic Exploration"  
Project No. C00543, Project Period: 7 May 2016 – 31 December 2017  
Principal Investigator: Aly I. El-Kadi

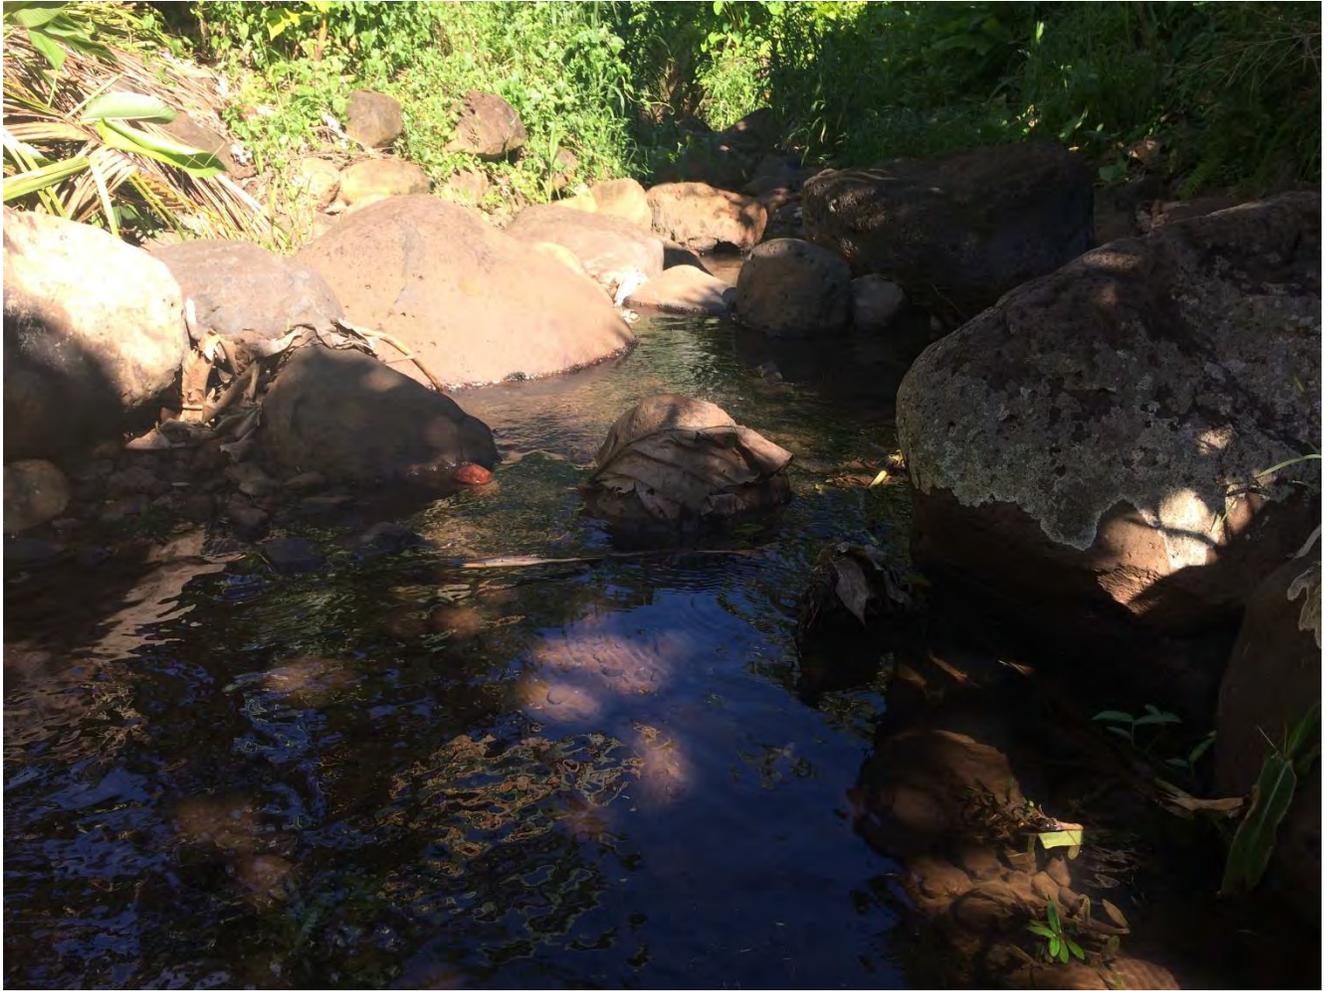
Control structure for Fagaitua gage, rocks center of photo. April 2017

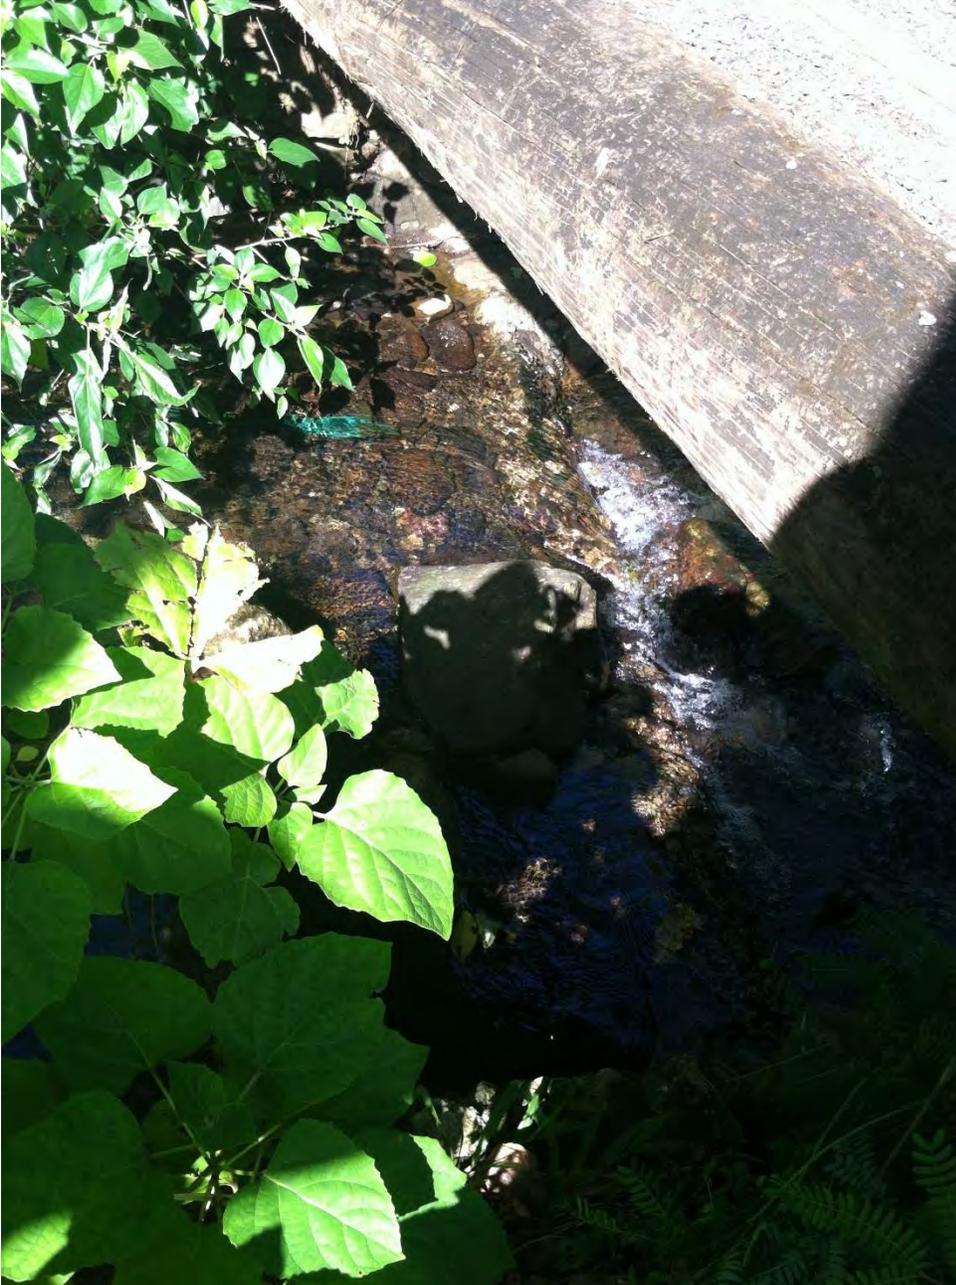
Terrible photo of control structure for Afono gage, shows old USGS concrete weir structure. Weir has a gap in the middle where a large boulder has lodged. April 2017
